Photo 1 – Longway Farm, 91 Janes Rd., Swanton, VT – 06/23/16
New concrete curbing around the heifer barnyard.

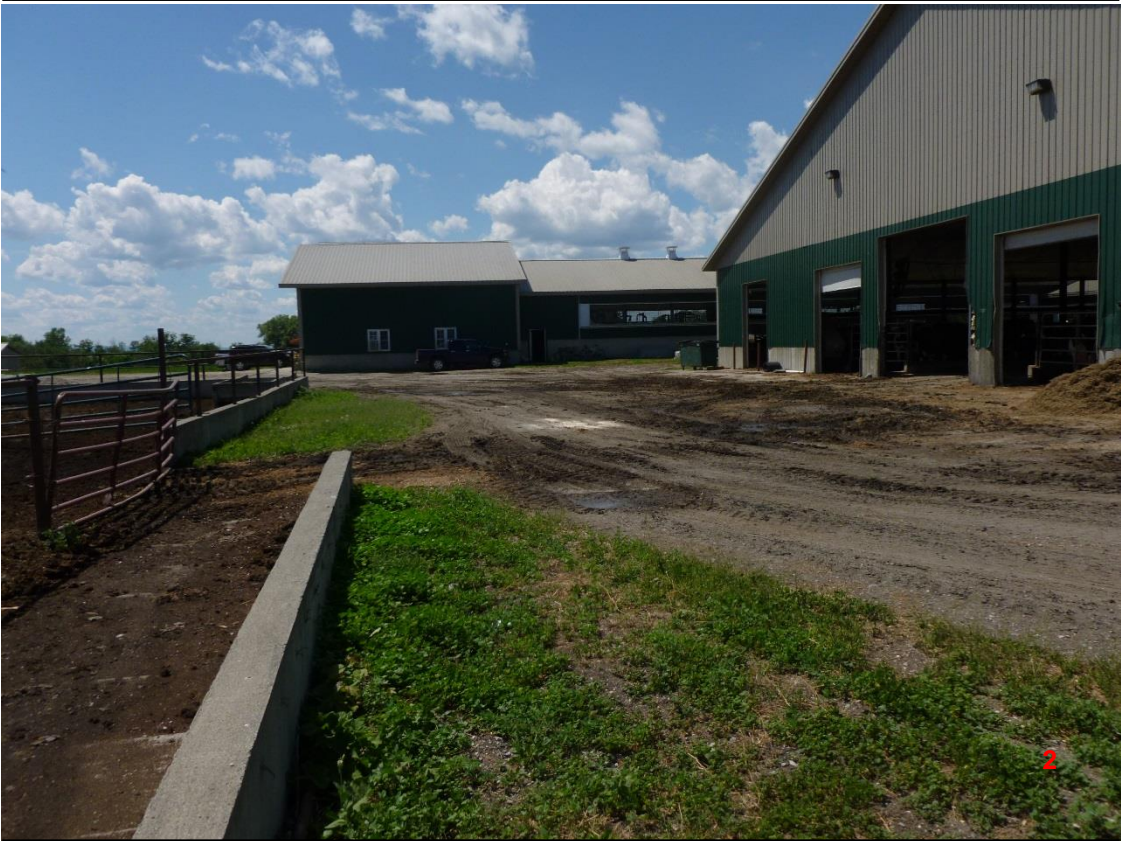
Photo 2 – Longway Farm, 91 Janes Rd., Swanton, VT – 06/23/16
Heavy use area outside the main barn where a new concrete pad will be installed.

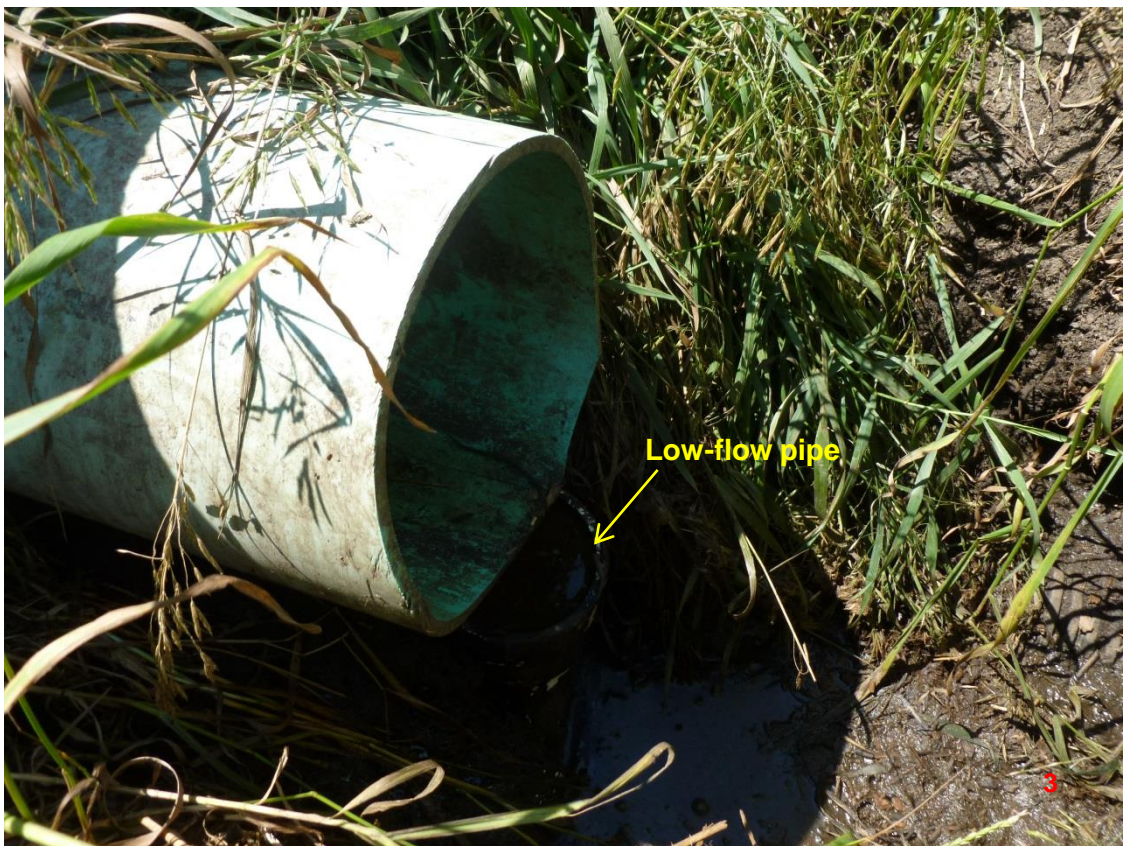
Photo 3 – Longway Farm, 91 Janes Rd., Swanton, VT – 06/23/16
Clogged low-flow pipe at silage collection system, runoff entering the high-flow treatment area.

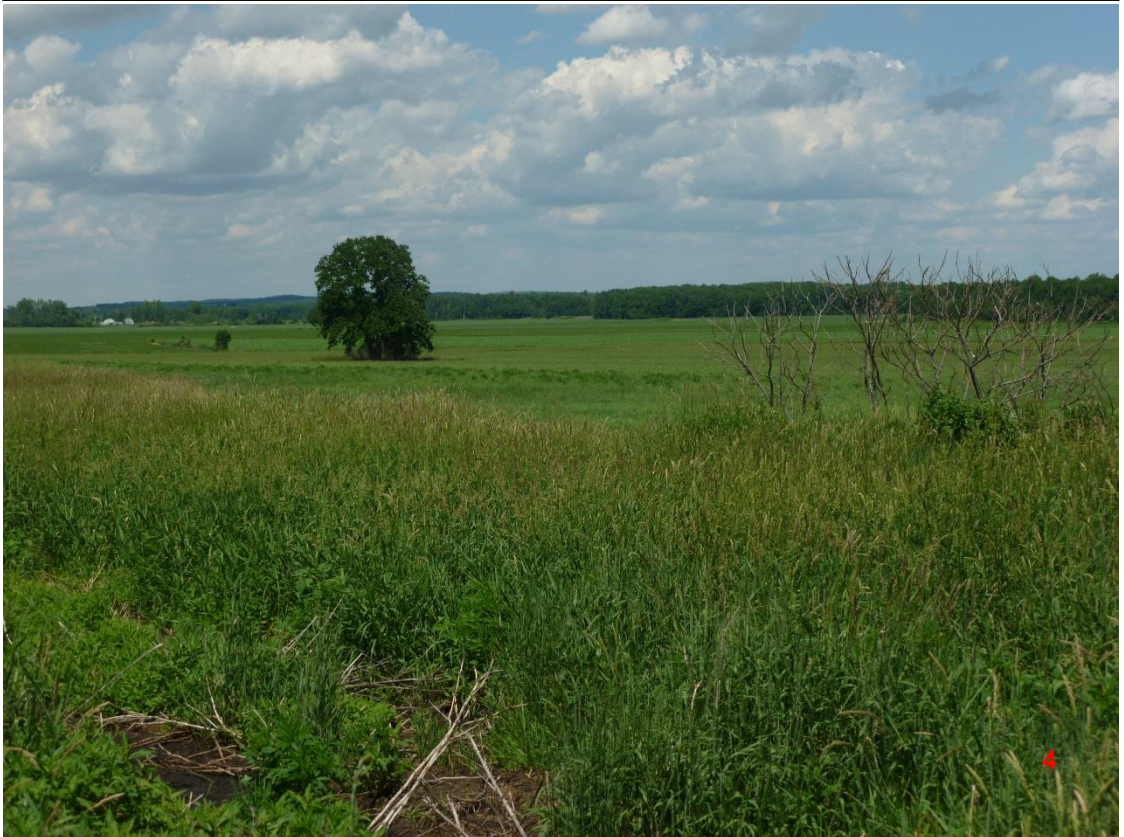
Photo 4 – Longway Farm, 91 Janes Rd., Swanton, VT – 06/23/16
View of the high-flow vegetated treatment area at the main farm.

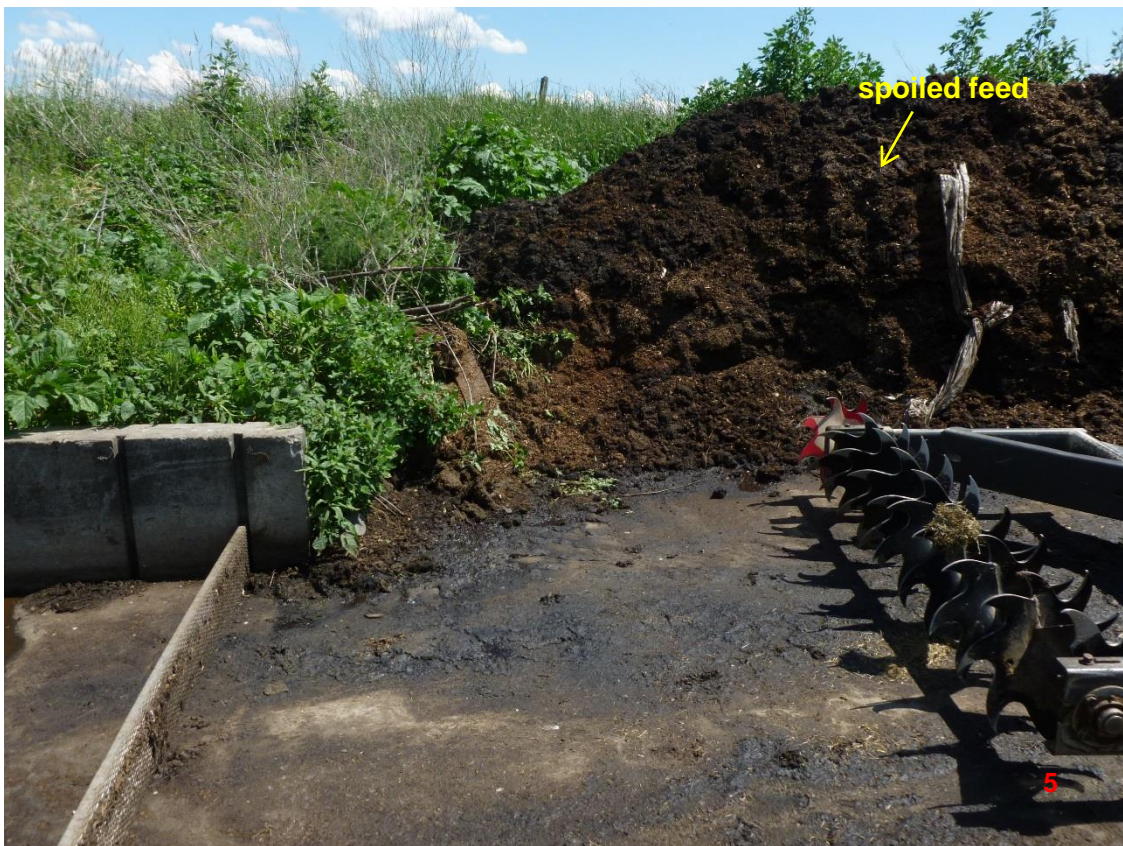
Photo 5 – Brodeur Farm, 123 Comstock Rd., Swanton, VT – 06/23/16

Spoiled feed pile near the silage collection system; build-up of solids at the intake screen.
